Site Visit Report	MDSHA MS4 (General Permit No. 99-DP-3313) Dayton Maintenance Facility & Pine Orchard Satellite Facility MDSHA District No. 7	Site Visit Date: 11/20/2013
--------------------------	---	--------------------------------

Facility Name: Dayton Maintenance Facility
Location: 4401 Route 32, Dayton, MD 21036

Date of Visit: November 20, 2013
Entry Time: 8:00 a.m. (approx)
Exit Time: 11:30 a.m. (approx)

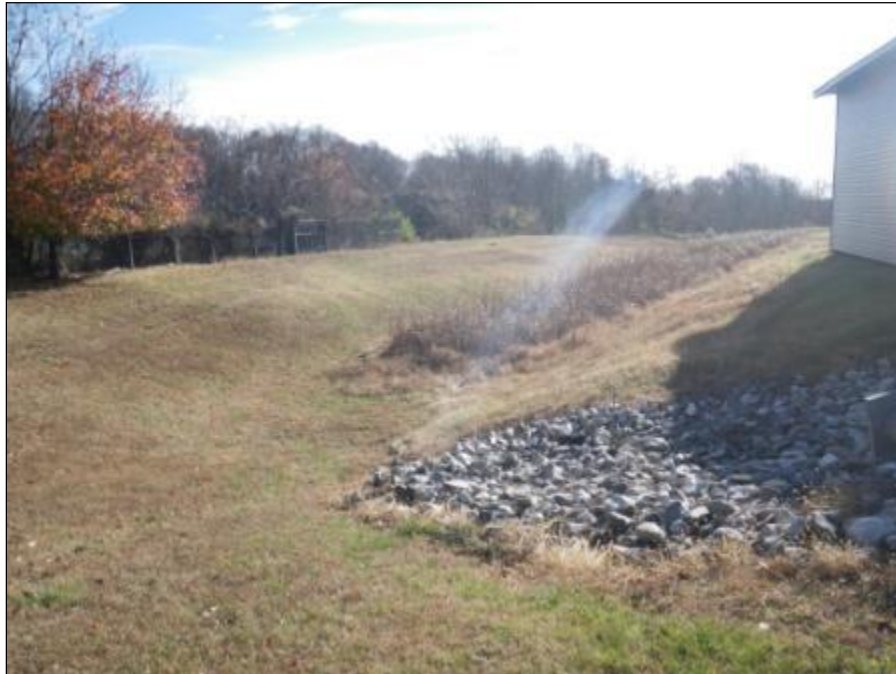
The ground surface of the Facility is mostly impervious and stormwater runoff is primarily conveyed via overland flow offsite or to permanent onsite bioretention basins. There are two individual bioretention basins in the northeastern and southeastern portions of the Facility (refer to Photographs 1 and 2) and three additional bioretention basins which are connected in series in the southwestern portion of the Facility.

Photograph 1. View of the bioretention basin in the northeastern portion of the Facility.

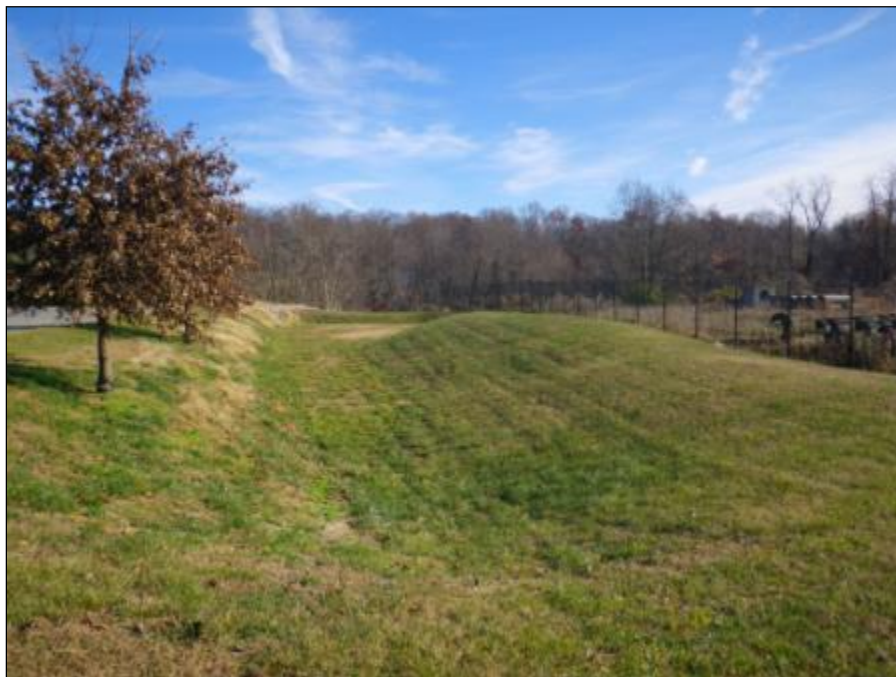
Photograph 2. View of the bioretention basin in the southeastern portion of the Facility.

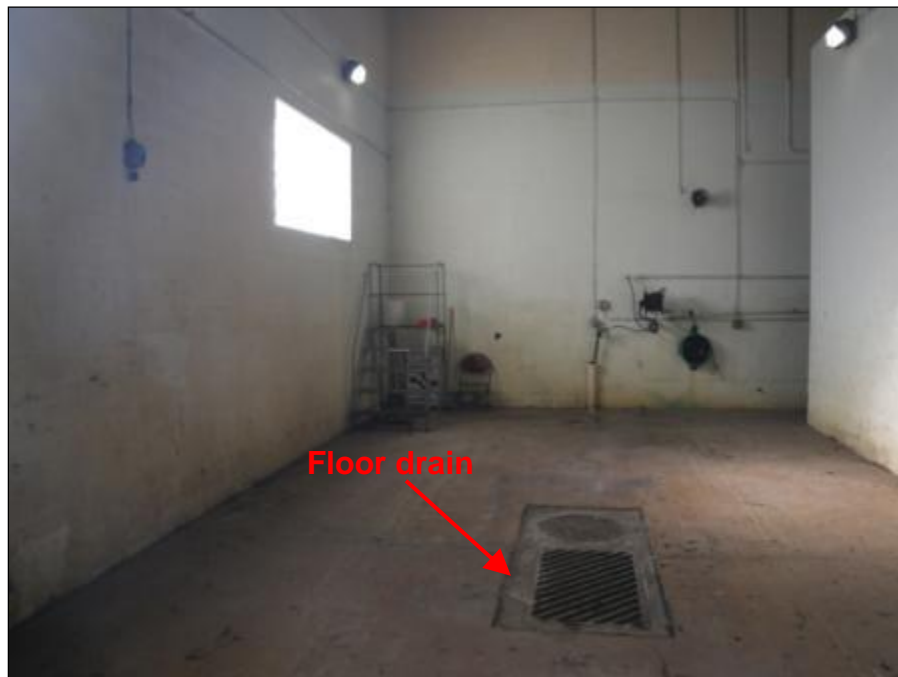
4. The Facility has an indoor vehicle wash bay (refer to Photograph 3) which is connected to an oil/water separator and discharges to an underground 500-gallon holding tank which is pumped out as needed. MDSHA staff explained the oil/water separator and holding tank are inspected quarterly, and cleaned or pumped out as needed, by Maryland Environmental Services (MES). MES provides the Facility with a formal report of each inspection/cleaning event. The EPA Inspection Team viewed the inspection records from spring 2013, which were maintained onsite. The Environmental Compliance Division Chief explained that MDSHA maintains coverage under an individual National Pollutant Discharge Elimination System (NPDES) permit in the event that the Facility needed to

Photograph 3. View of the indoor vehicle wash bay. Note that the floor drain is connected to an oil/water separator which discharges to an underground 500-gallon holding tank.

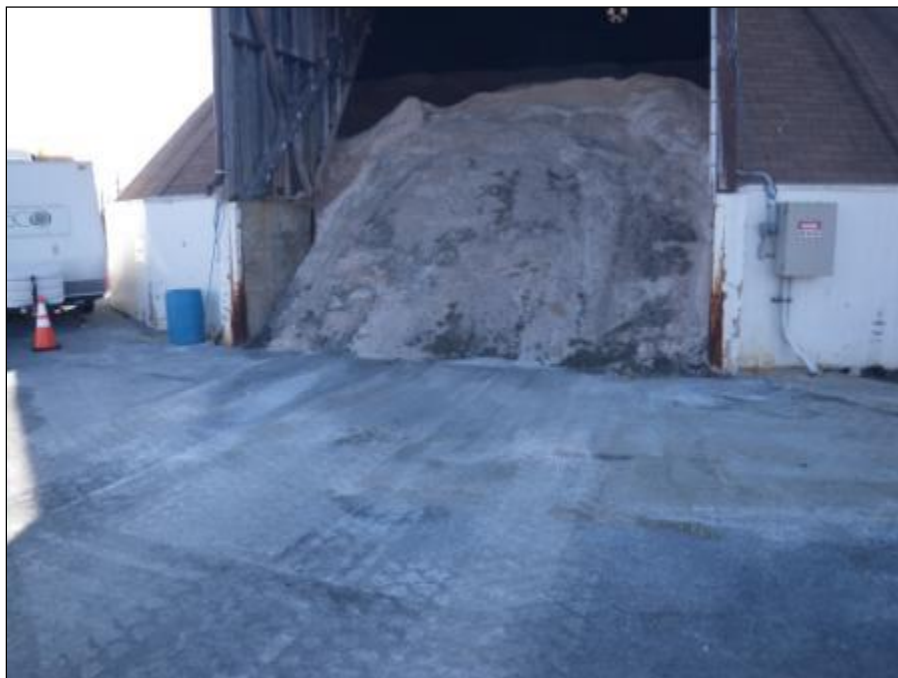
6. Salt residue was present on the impervious ground surface adjacent to the salt storage dome (refer to Photographs 4 through 6). The DEC and Facility staff explained the Facility maintains about six “night trucks” which are dump trucks fitted with a plow attachment and loaded with salt each evening during the winter operation season. They explained that these trucks are loaded and unloaded each day when they may be needed in the winter so they can be dispatched from staff members’ homes rather than the Facility itself. Table 6 of the Facility SWPPP/SPCC identifies sweeping after loading and unloading activities as a non-structural best management practice (BMP) for the salt dome area. The staff explained that sweeping is conducted after use but it is difficult to ensure no salt residue or salt is beyond the salt storage dome when these operations are underway for the season. The Facility site map depicts that stormwater runoff from this area would flow overland and offsite to the east.

Photograph 4. View of the Facility's salt storage dome. Note that white salt residue was present on the impervious ground surface adjacent to the structure.

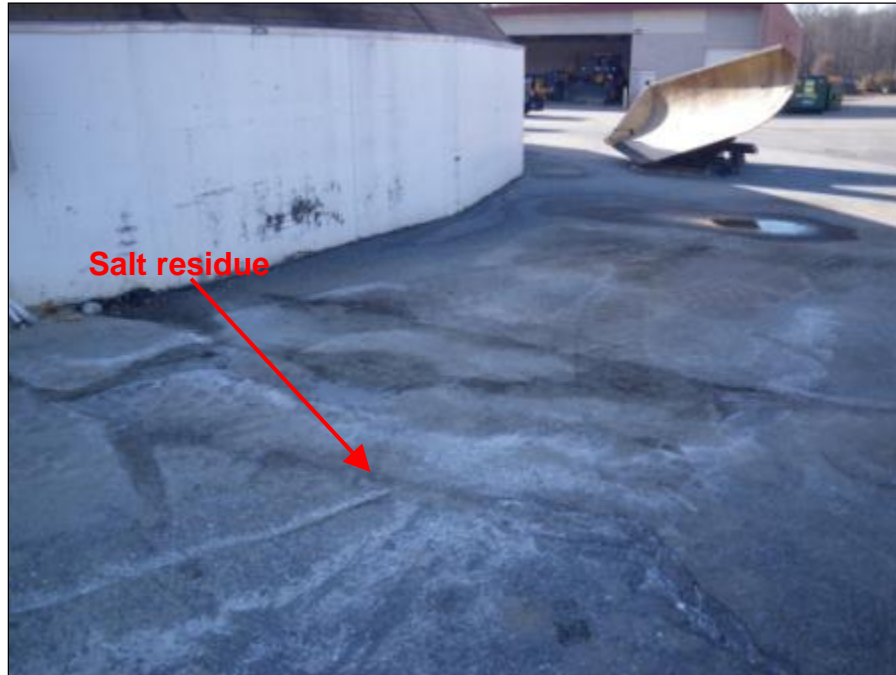
Photograph 5. View of white salt residue on the ground surface adjacent to the salt storage dome.

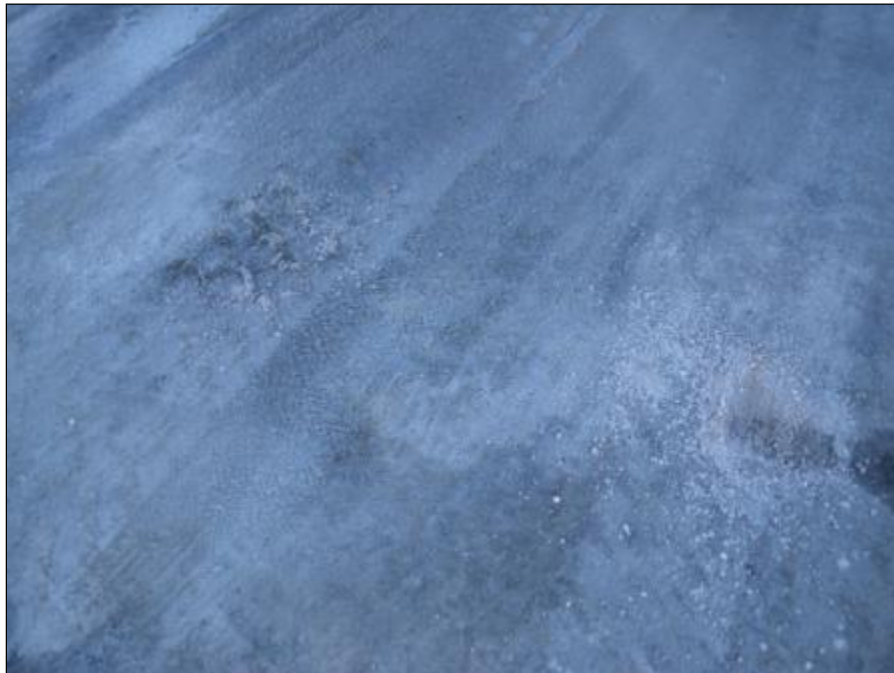
Photograph 6. Close-up view of salt and white salt residue on the ground surface adjacent to the salt storage dome.

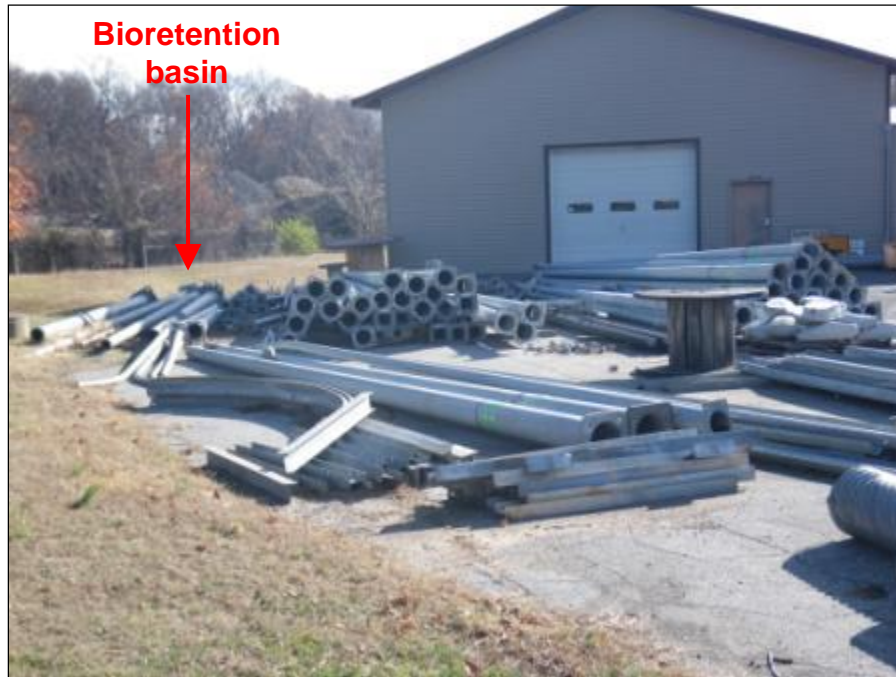
7. Metal materials were stored outside on an impervious ground surface upgradient of the bioretention basin in the northeastern portion of the Facility (refer to Photograph 7).

Photograph 7. View of metal materials stored outside on an impervious ground surface upgradient of the bioretention basin in the northeastern portion of the Facility.

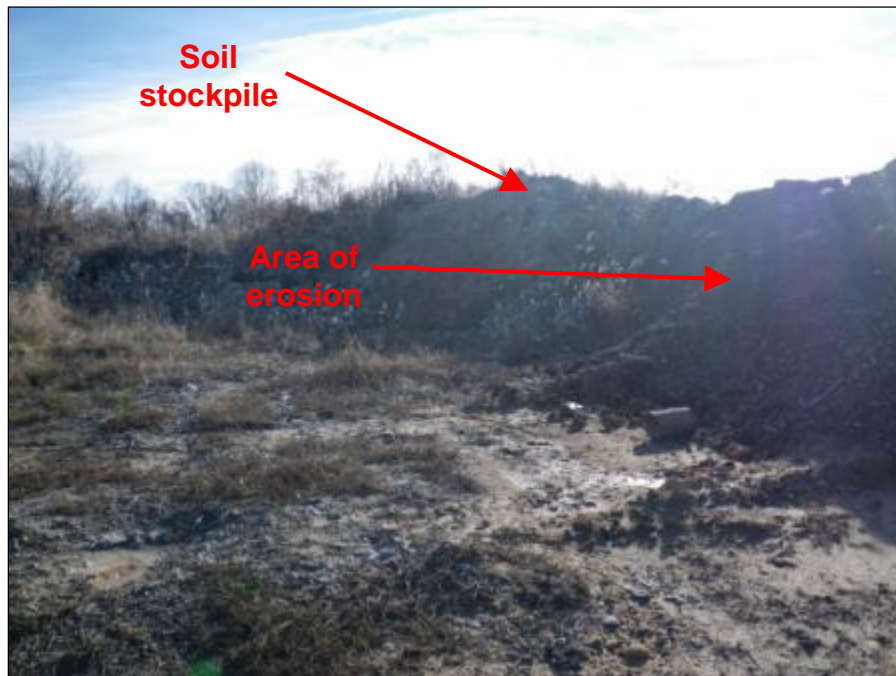
8. Evidence of erosion was observed on the slope of a soil stockpile and adjacent drainage area in the northeastern portion of the outdoor stockpile area of the Facility (refer to Photographs 8 through 10). According to the DEC, this issue was noted by the DEC in his report for the quarterly inspection conducted August 28, 2013, but corrective action had not been performed. It appeared that stormwater runoff from this location would flow offsite to the east.

Photograph 8. View of soil stockpile in the northeastern portion of the outdoor stockpile area of the Facility. Note area of erosion on slope of the soil stockpile.

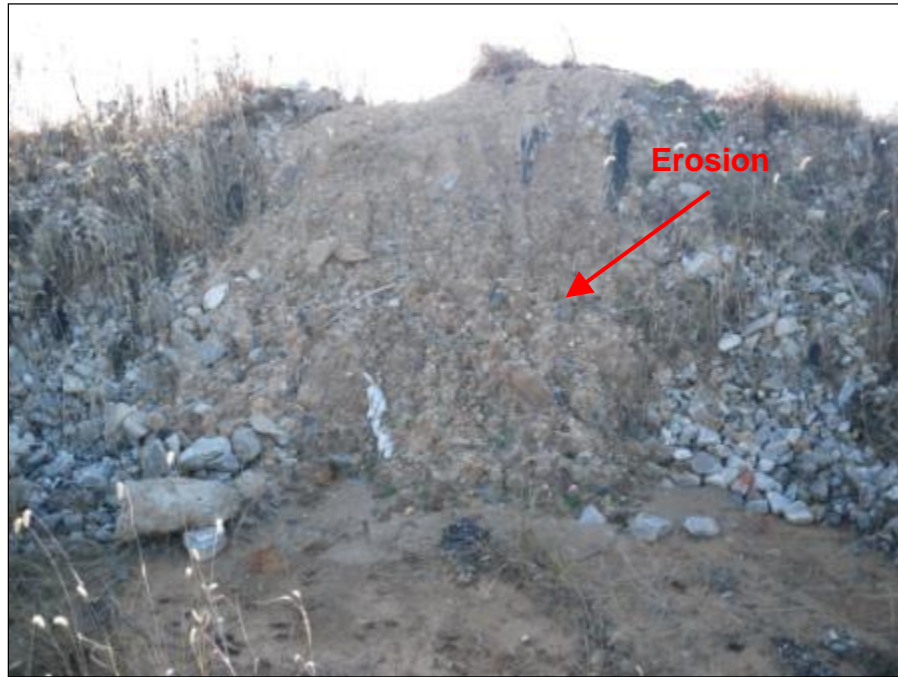
Photograph 9. Close-up view of area of erosion on the soil stockpile shown in previous photograph.

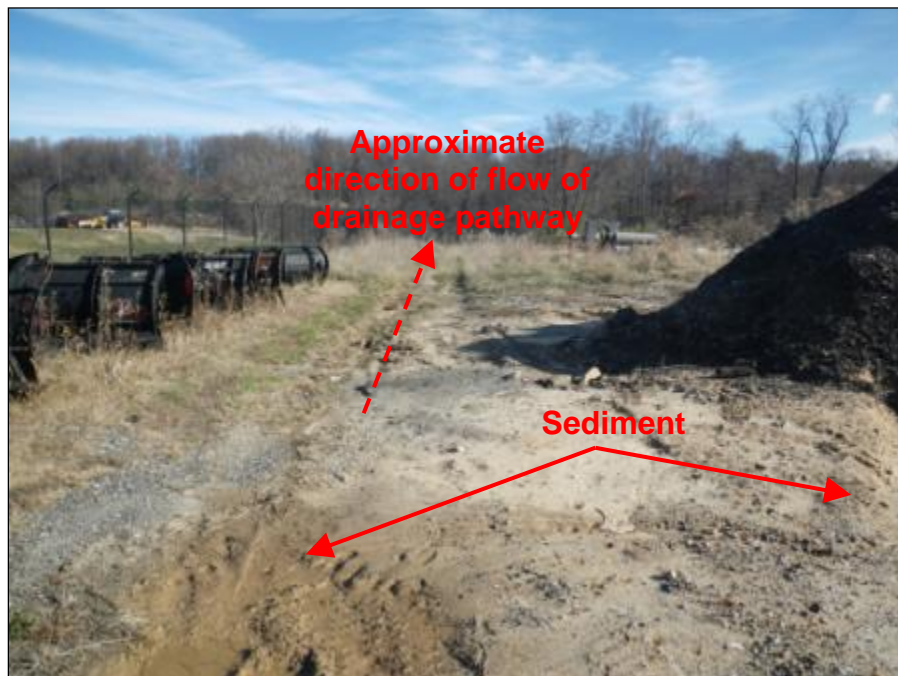
Photograph 10. View of sediment downgradient of eroded soil stockpile shown in previous photographs. Sediment which appeared to have been transported from the stockpile was present in a drainage pathway that leads to the east. Soil stockpile is just out of the photograph frame to the right.

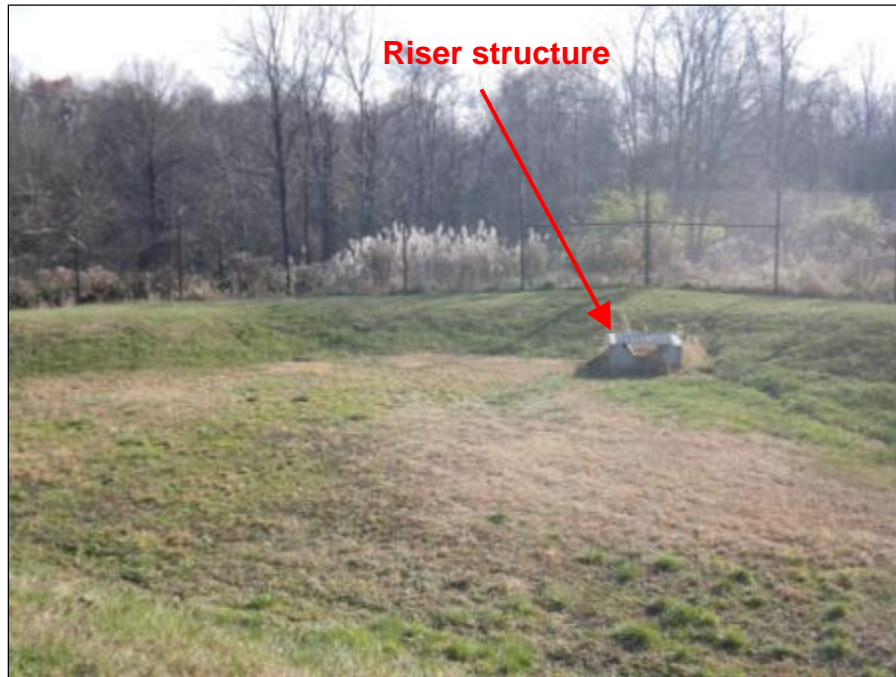
9. The Facility site map included in the SWPPP/SPCC did not depict the location of the discharge pipe and outfall from the riser structure for the bioretention basin in the southeastern portion of the Facility (refer to Photograph 11).

Photograph 11. View of the outfall riser structure for the bioretention basin in the southeastern portion of the Facility. Note that the Facility site map included in the SWPPP/SPCC did not depict the location of the discharge pipe and outfall downgradient of the riser structure.

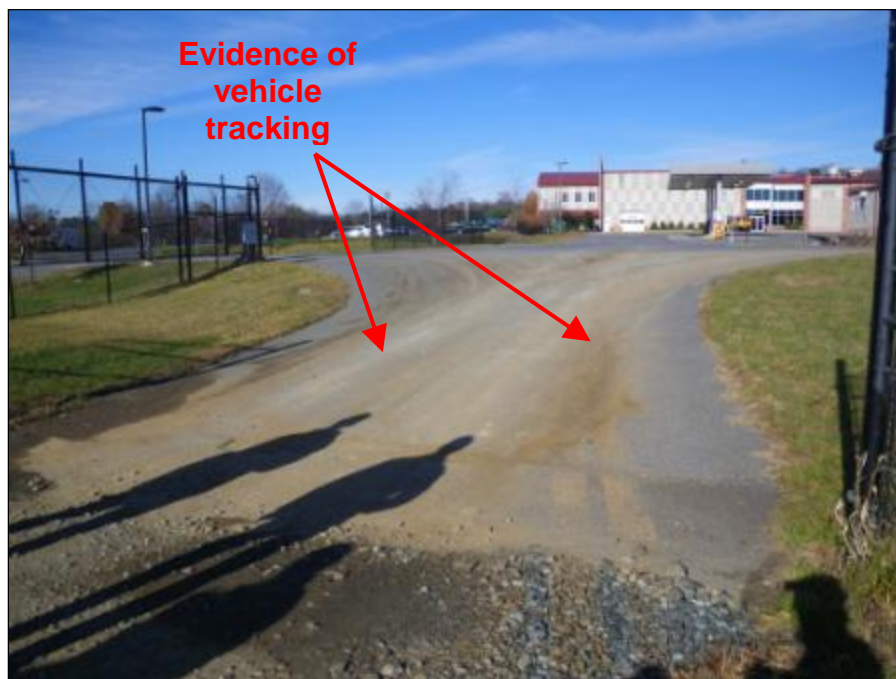
10. Evidence of vehicle tracking and transport of sediment to the adjacent impervious surface was observed at the entry to the outdoor stockpile area in the southern portion of the Facility (refer to Photographs 12 through 14). Table 6 of the Facility SWPPP/SPCC did not identify a stabilized construction entrance or other BMP to prevent the transport of sediment due to vehicle tracking from the stockpile area.

Photograph 12. View of sediment on impervious surface adjacent to entrance to the outdoor stockpile area in the southern portion of the Facility.

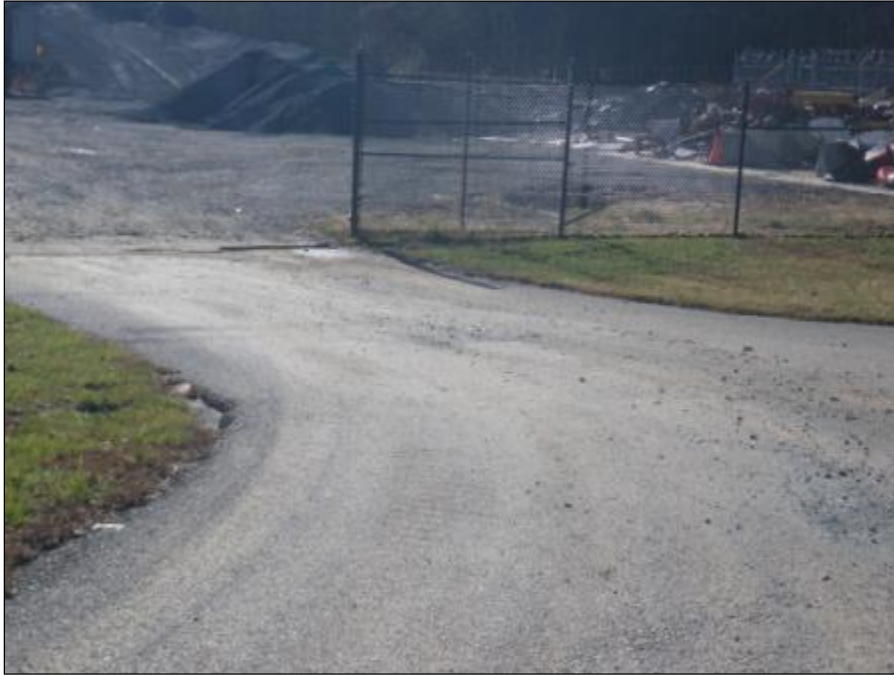
Photograph 13. Additional view of evidence of vehicle tracking at entrance to outdoor stockpile area.

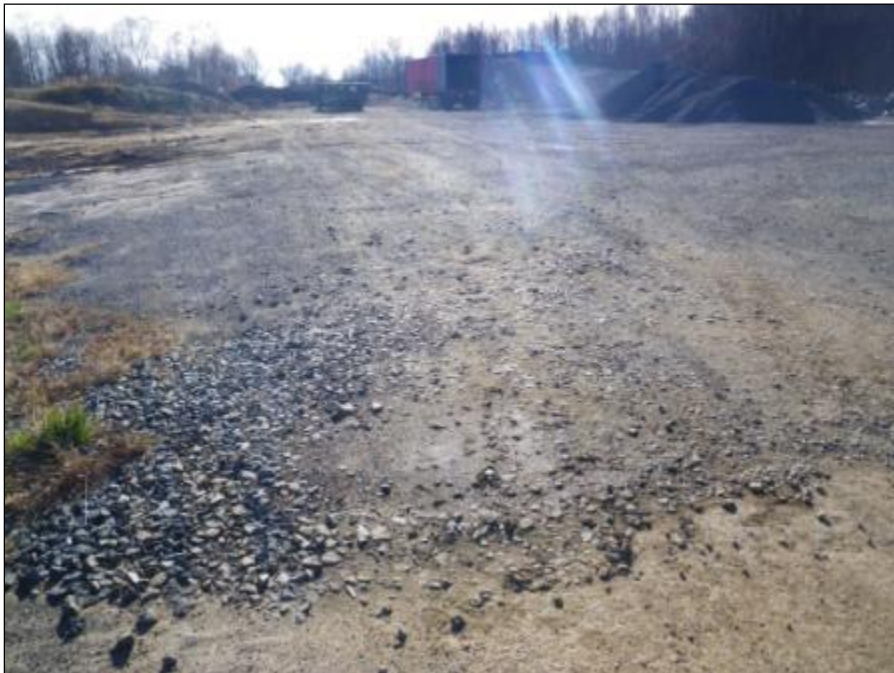
Photograph 14. View facing southeast into the outdoor stockpile area from the entrance. Note that the ground surface at the entrance was unstabilized.

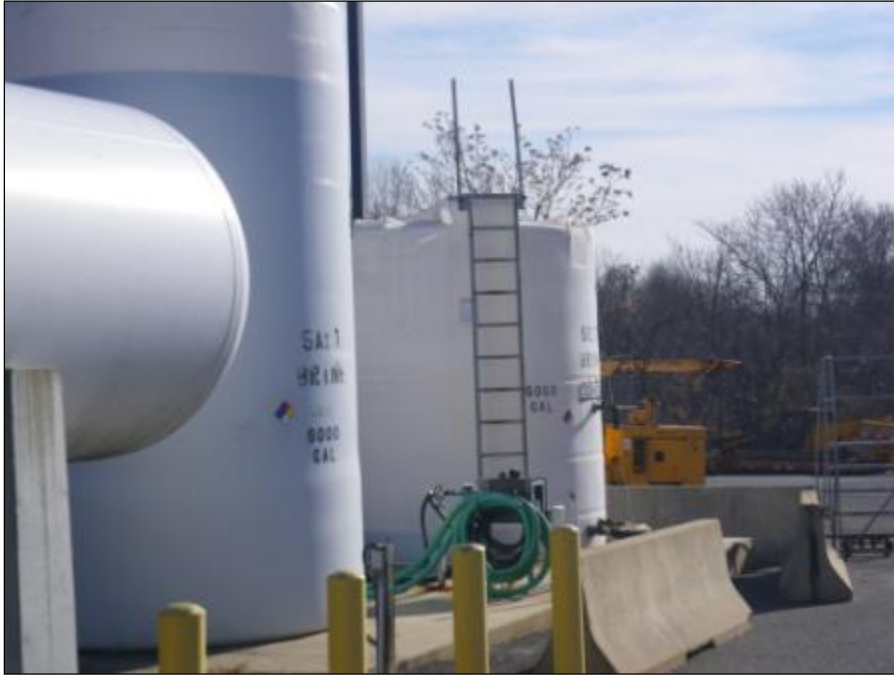
11. The salt brine storage tanks located in the northeastern portion of the Facility (Area No. 8 on the Facility site map) were not located within secondary containment (refer to Photographs 15 and 16). The Facility site map depicts that stormwater runoff from this area would flow overland and offsite to the east.

Photograph 15. View of the salt brine storage tanks located in the northeastern portion of the Facility. Note that the tanks were not located within secondary containment.

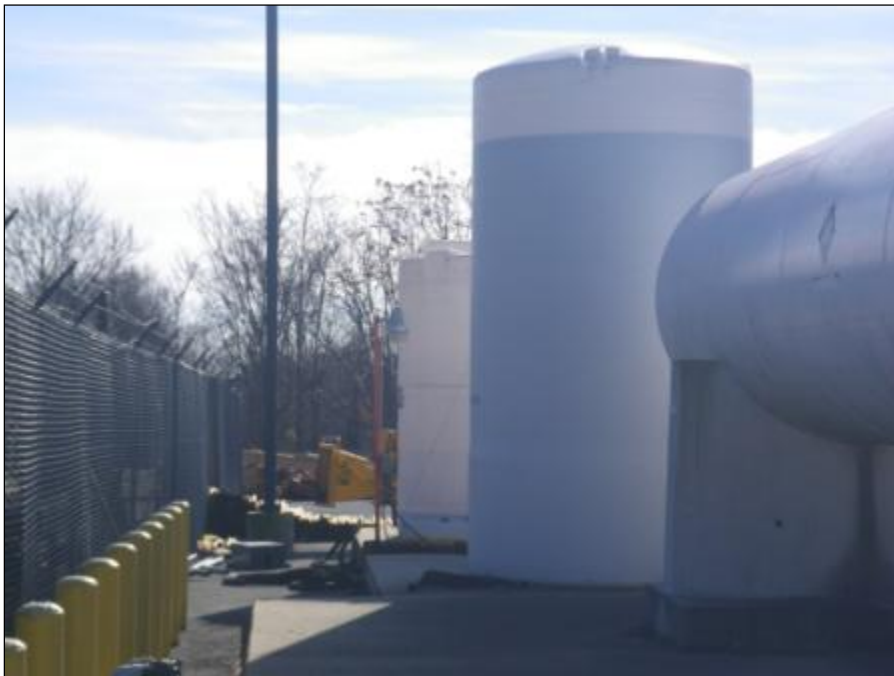
Photograph 16. Additional view of the salt brine storage tanks shown in previous photograph.

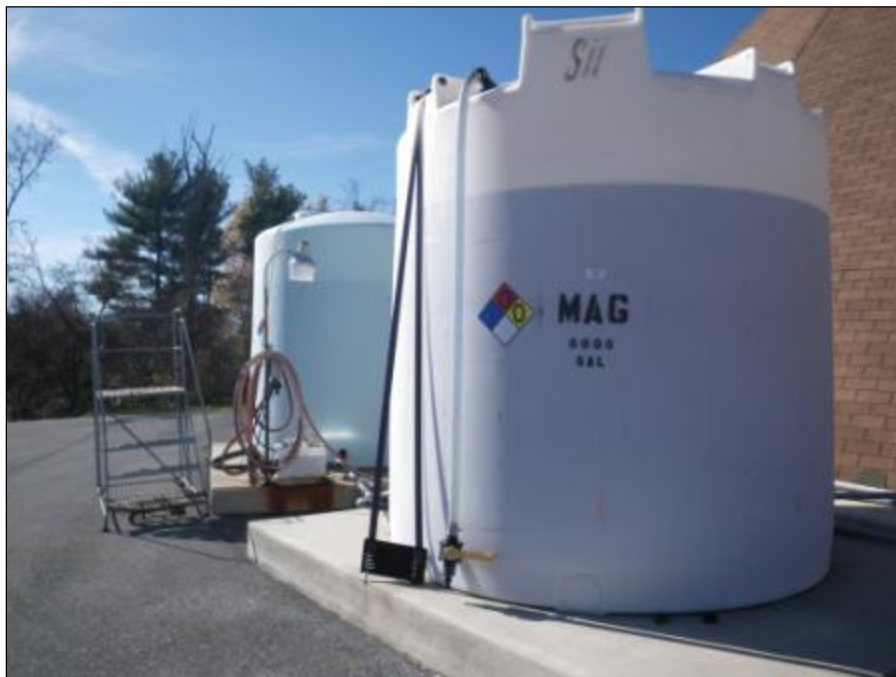
14. The salt brine and magnesium chloride storage tanks at the Satellite Facility were not located within secondary containment (refer to Photographs 17 and 18).

Photograph 17. View of salt brine and magnesium chloride storage tanks at the Satellite Facility. Note that the tanks were not located within secondary containment.

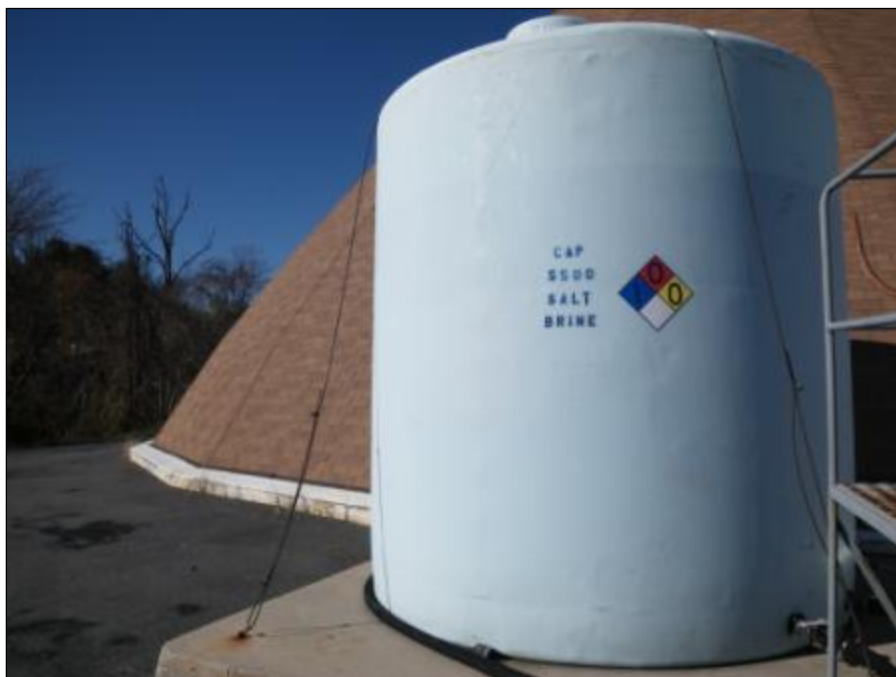
Photograph 18. Closer view of the salt brine storage tank shown in previous photograph.

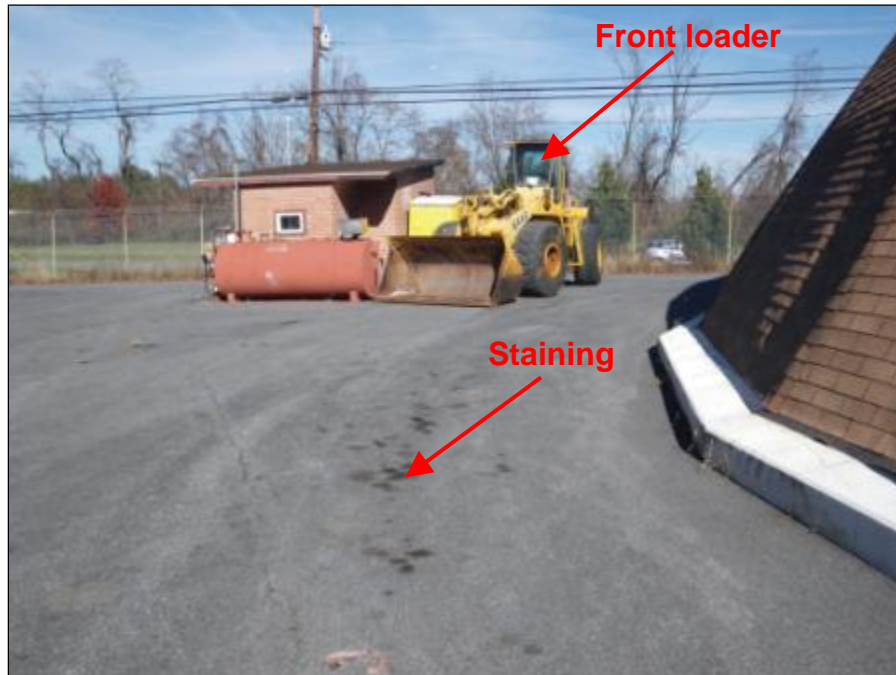
16. Staining was present on the impervious ground surface to the west of the salt storage dome and underneath a front loader stored at the Satellite Facility (refer to Photographs 19 and 20).

Photograph 19. View of staining on the impervious ground surface on the west side of the salt storage dome.

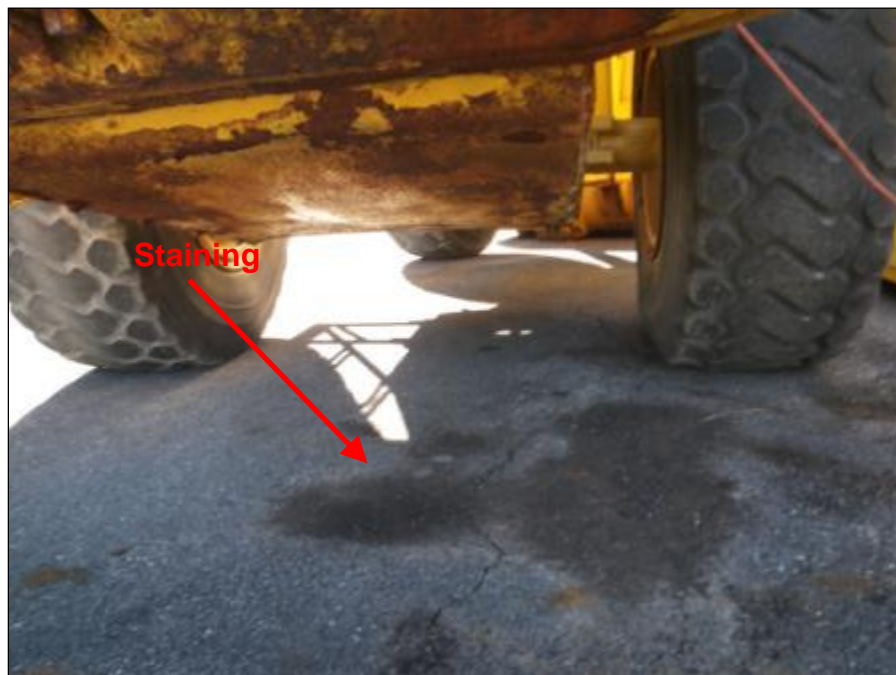
Photograph 20. Close-up view of staining under the front loader shown in previous photograph.
